Gabilan Creek Watershed Monitoring Report

January 2020 – May 2021

Submitted To:
Monterey County Water Resources Agency

Prepared By:
Jack Eschenroeder
Dana Lee

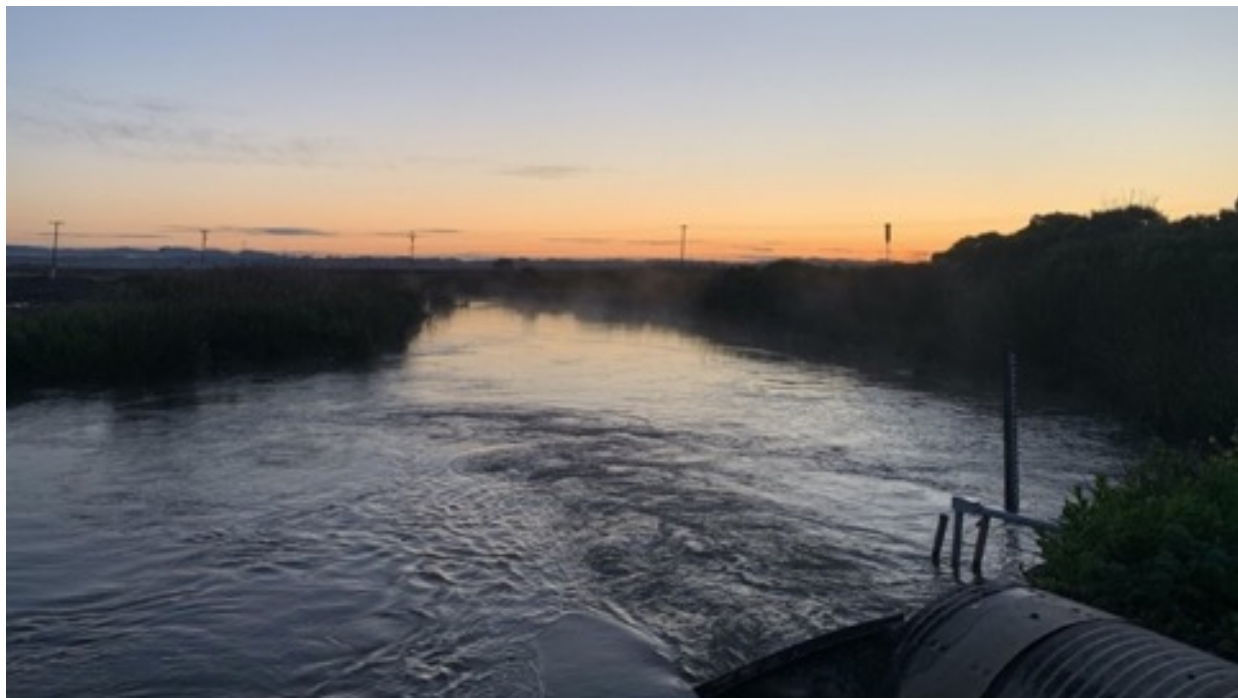
Figure 2. Sampling site at the Monterey Dunes Way crossing of Old Salinas River (OSR). Photo taken April 7, 2020.

The two locations furthest downstream were at the Monterey Dunes Way crossing on the Old Salinas River (OSR; Figure 2) approximately 180 meters upstream of its confluence with Tembladero Slough, and at the Molera Road crossing of Tembladero Slough (TEM; Figure 3), approximately 100 meters upstream of its confluence with the Old Salinas River. The intention of monitoring TEM for *O. mykiss* eDNA was to detect any individuals moving upstream towards the Gabilan Creek watershed, whereas monitoring at OSR was to determine whether steelhead might be using the Old River as a migratory pathway in and out of the Salinas River, particularly during periods of sandbar closure at Salinas Lagoon.

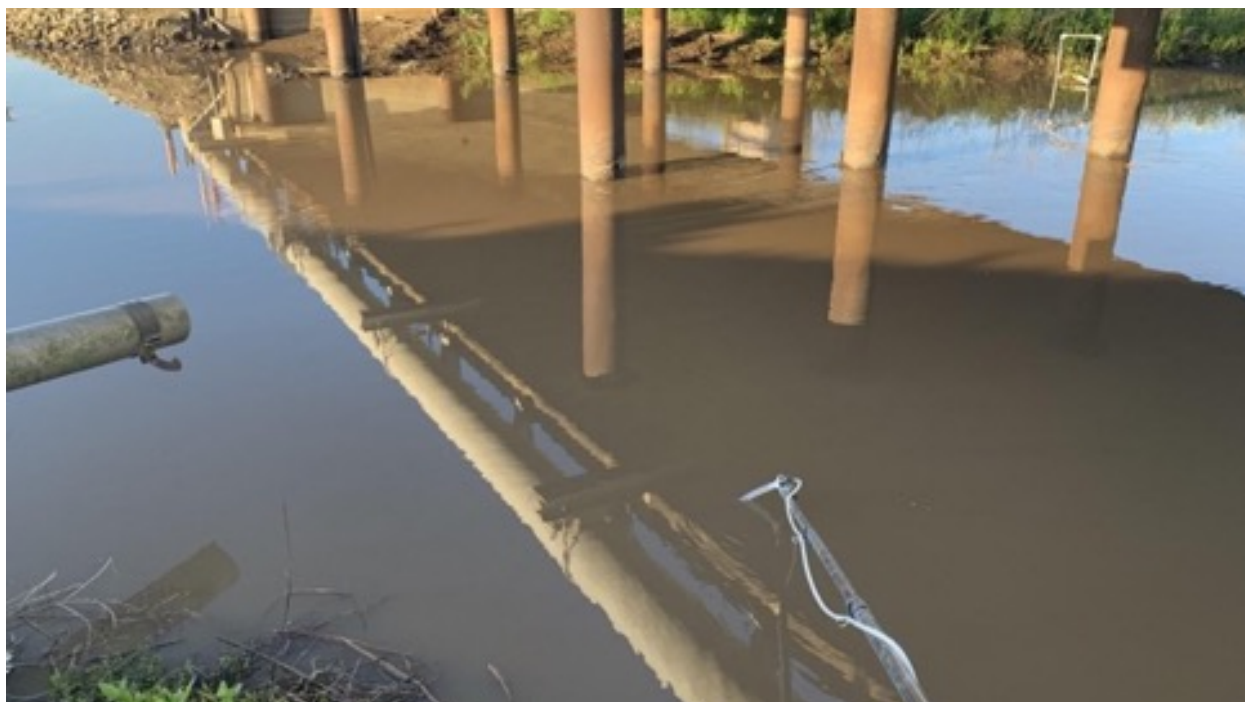
Figure 3. Sampling site at the Molera Road crossing of Tembladero Slough (TEM). Photo taken March 31, 2020.

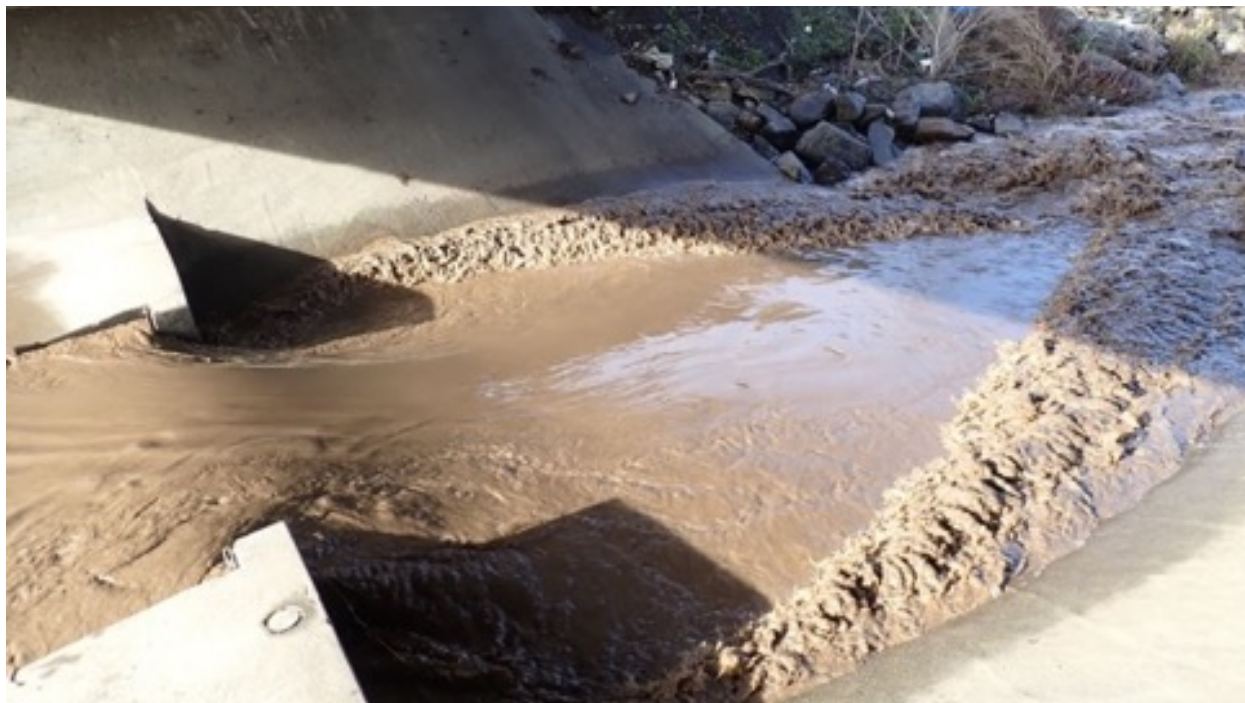
Figure 4. The sampling site located at the San Jon Road crossing of Gabilan Creek (SJR). This photo was taken during a period of high flow on January 17, 2020.

The next upstream site was at the San Jon Road crossing of Gabilan Creek (SJR; Figure 4). This site is located between the cities of Castroville and Salinas and is surrounded by agricultural fields. Frequent irrigation on these fields likely contributes to runoff in this reach. The next two sites were

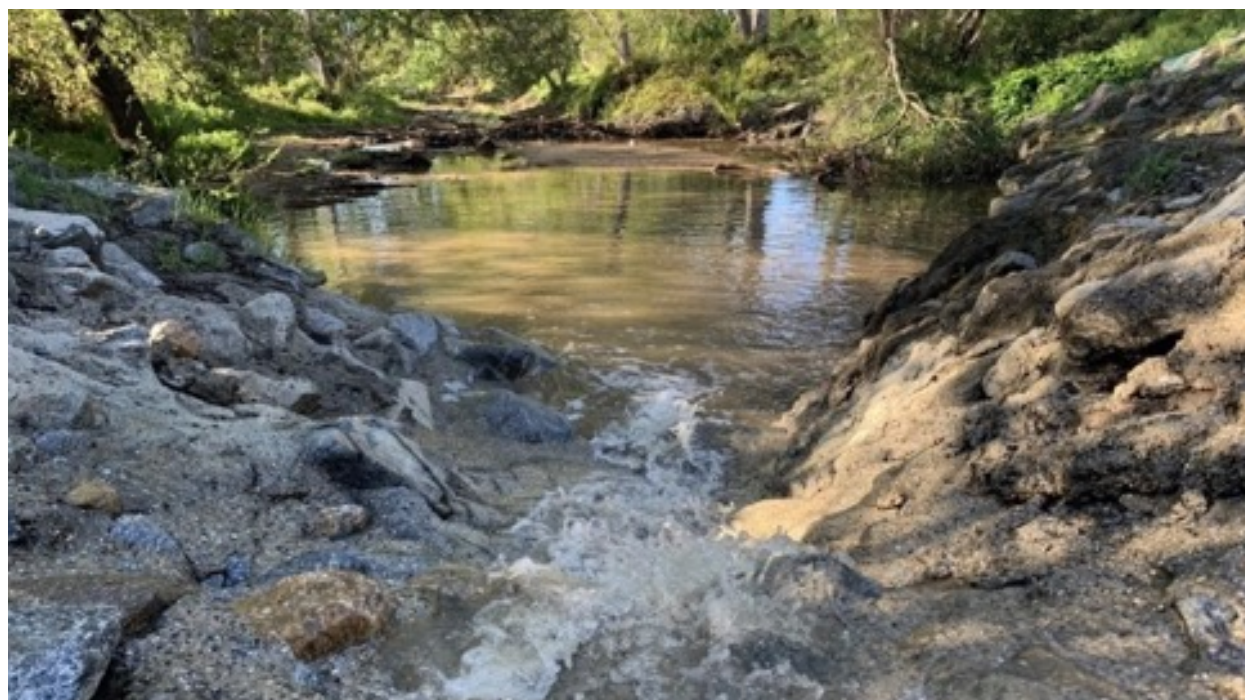
Figure 5. The barrier and pool located at Little River Drive in the City of Salinas. Although the sample site at the downstream end of the pool (LRD) maintained flow for the duration of the study, the streambed upstream of the barrier (LRU) was frequently dry. Photo taken April 7, 2020.

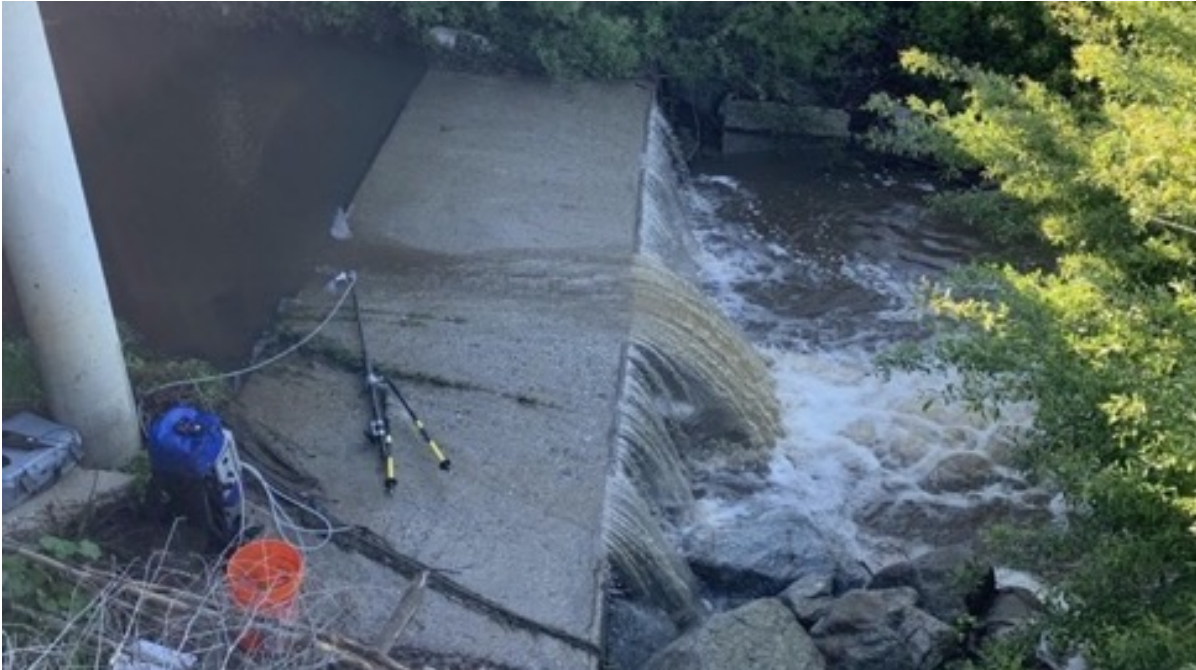
Figure 6. The sampling site located at the Hebert Road crossing (HEB). The height from the top of the barrier to the substrate below was 1.22 meters (four feet), as measured during a period of no flow. Photo taken April 7, 2020.

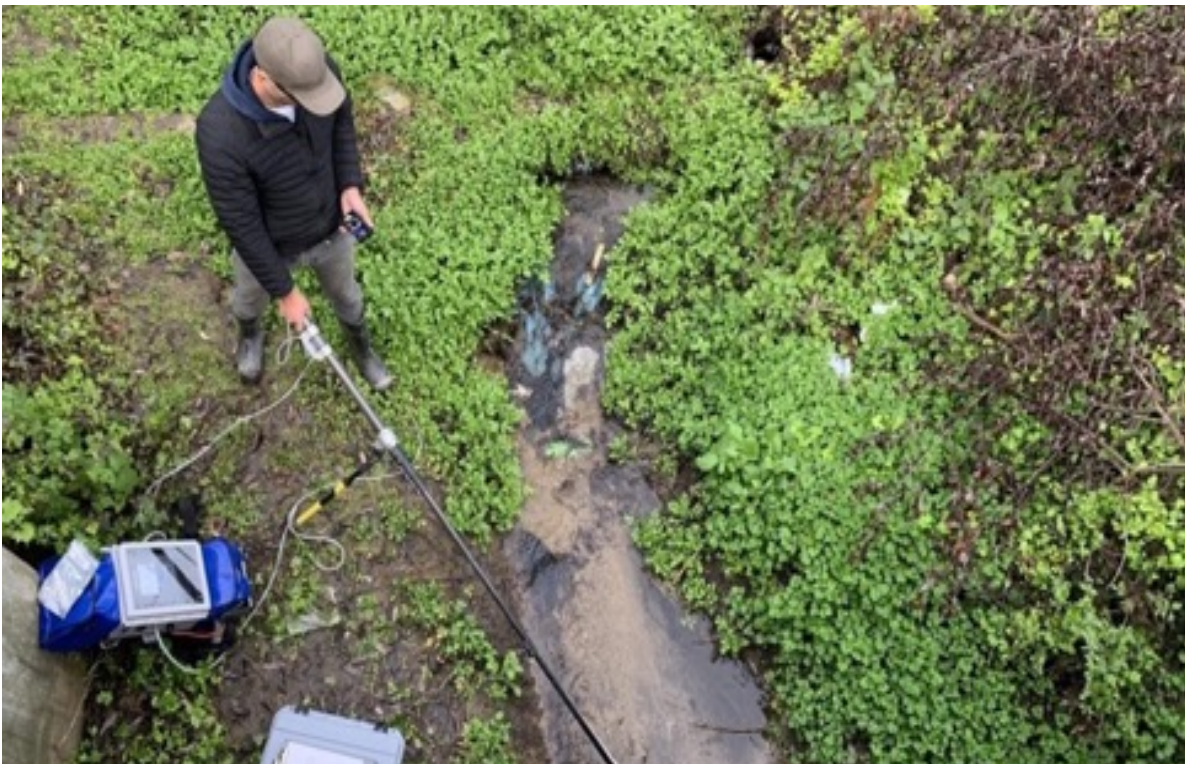
Figure 7. Sampling underneath the bridge at the Old Stage Road crossing of Gabilan Creek (SRC), just above the barrier formed by a retaining wall and pipeline. Photo taken January 31, 2020.

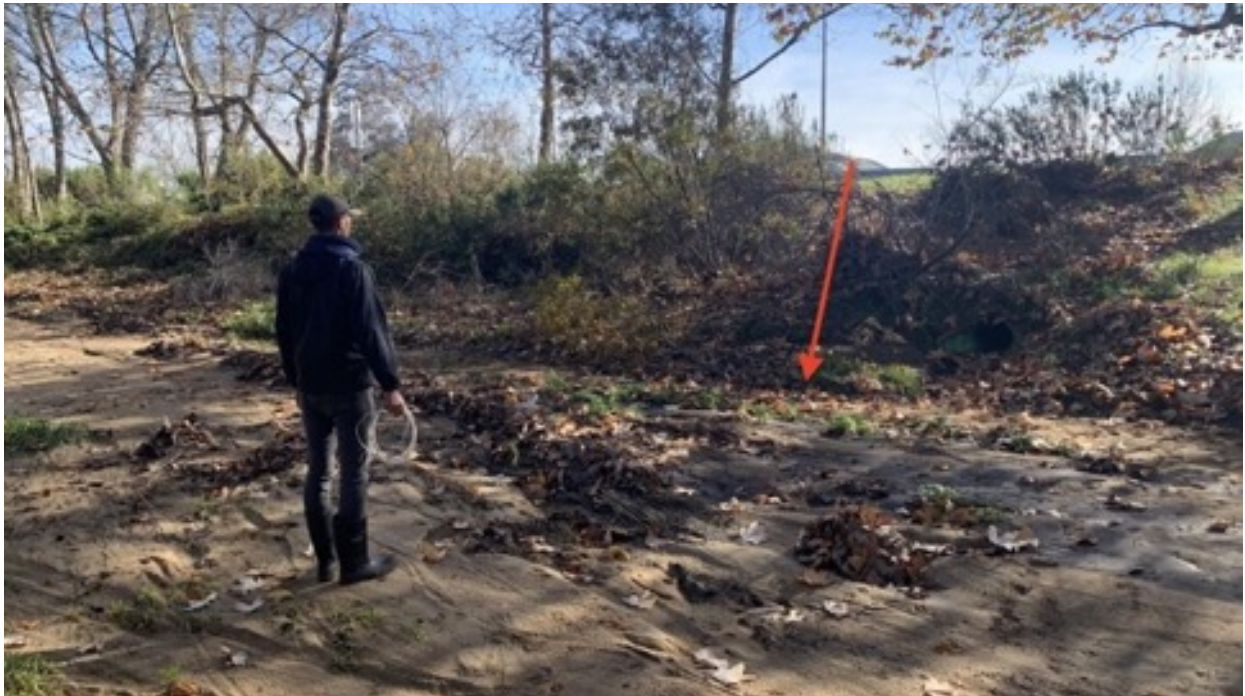
Figure 8. BOR logger site at the time of deployment (January 24, 2020). Arrow indicates the position of the logger.

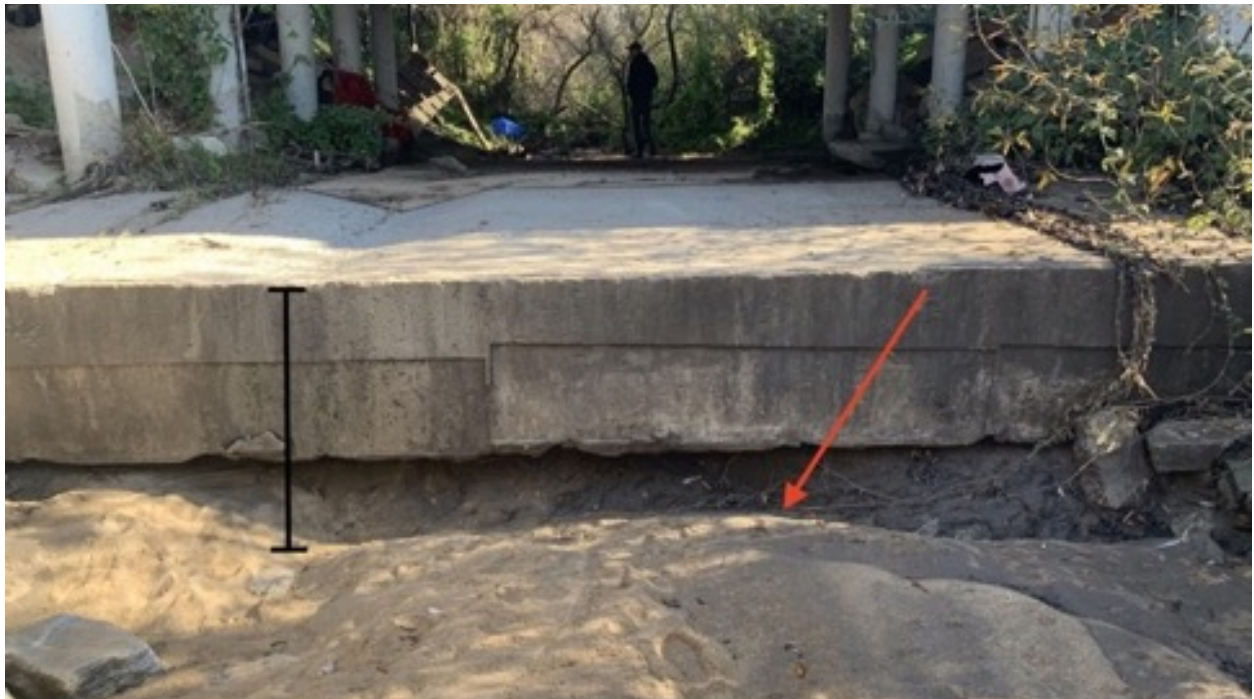
Figure 9. HEB logger site at the time of deployment (January 24, 2020). Arrow indicates the position of the logger, black line indicates height of the barrier, which was 1.22 m above the substrate.

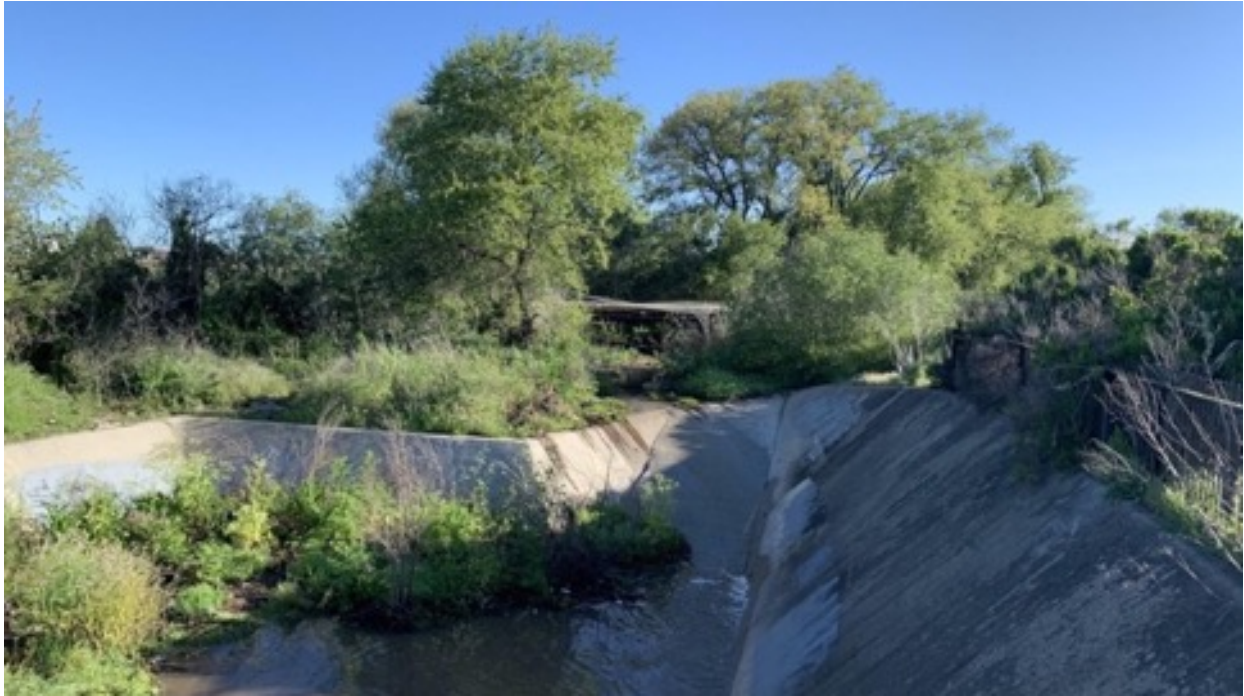
Figure 10. The large concrete barrier located just north of the Boronda Road crossing on Gabilan Creek. Photo was taken on April 7, 2020, 24 hours after a large precipitation event. Laminar flow down the concrete ramp suggests this barrier may have remained impassable at all but the highest flows experienced in 2020.

The standard operating procedure for critical riffle analysis for fish passage in California (Haas 2017) states the minimum depth of instream flow required to facilitate adult steelhead passage is 0.7 feet (~21 cm). Review of the water level logger data indicates that BOR was only above this threshold for one hour on March 16 (Figure 11) and for six hours on April 5. Although the BOR logger was placed near the eastern bank of the creek, the lack of a clear thalweg in this stretch along with the presence of a storm sewer inflow pipe immediately adjacent to the logger suggest that it likely experienced as much or greater depth than any other location across the width of the stream bed. Moreover, even if this threshold is conservative, it is unlikely the barrier located approximately 0.25 km upstream near the Boronda Road crossing (Figure 10) would have been passable at lower flows.

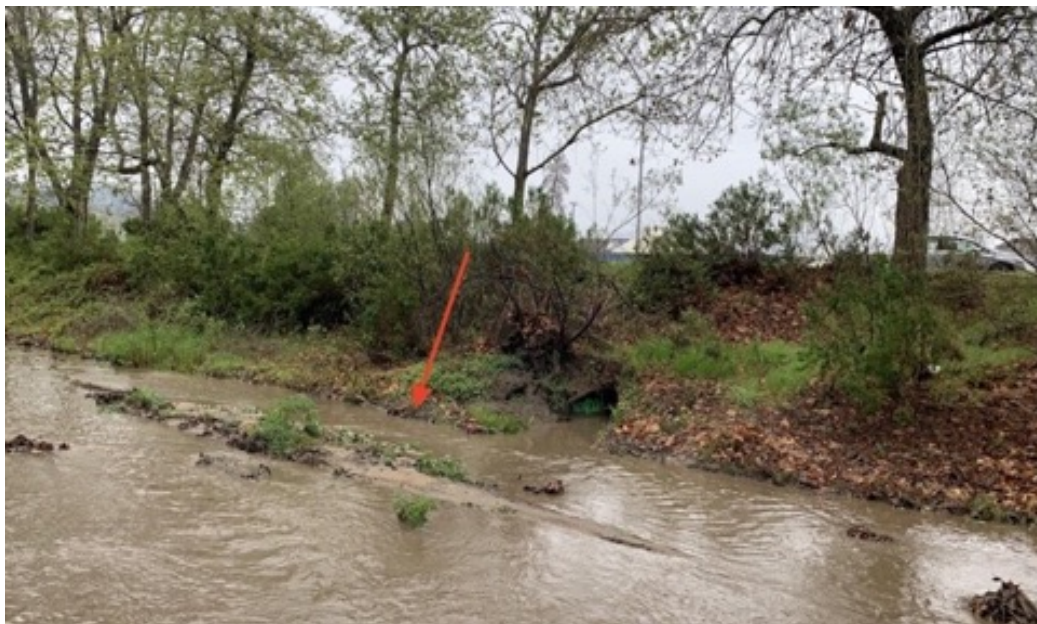
Figure 11. The BOR water level logger location during the high flow event on March 16, 2020. Arrow indicates the position of the logger.

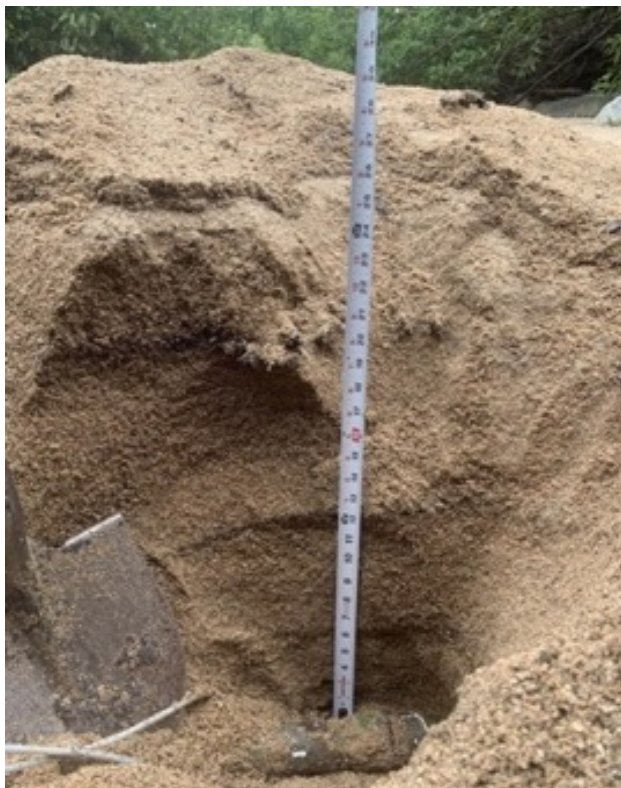
Calculated water levels based on data from the HEB logger were significantly higher and more persistent than those for BOR. This was expected, as the HEB logger was placed at the lowest point in a pool immediately underneath the small waterfall caused by the concrete barrier under Hebert Road. According to NOAA's Guidelines for Salmonid Passage at Stream Crossings (National Marine Fisheries Service 2001), salmonids require a pool depth of at least 1.5 times the jump height or a minimum of 0.6 meters (whichever is deeper) in order to successfully clear a barrier. Filtering the HEB logger data indicates that these standards were met from April 5 through April 13, however, this time period coincides with the largest precipitation event during the monitoring period (2.29 cm on April 5; Table 4), at which time the logger became buried under a significant amount of sediment (~71 cm; Figure 12). As such, the pressure readings during this period were not an

Figure 12. The Hebert Road (HEB) water level logger was buried under approximately 71 cm (~28 inches) of sand sometime during or following the large rain event on April 5. Photo taken April 16, 2020.

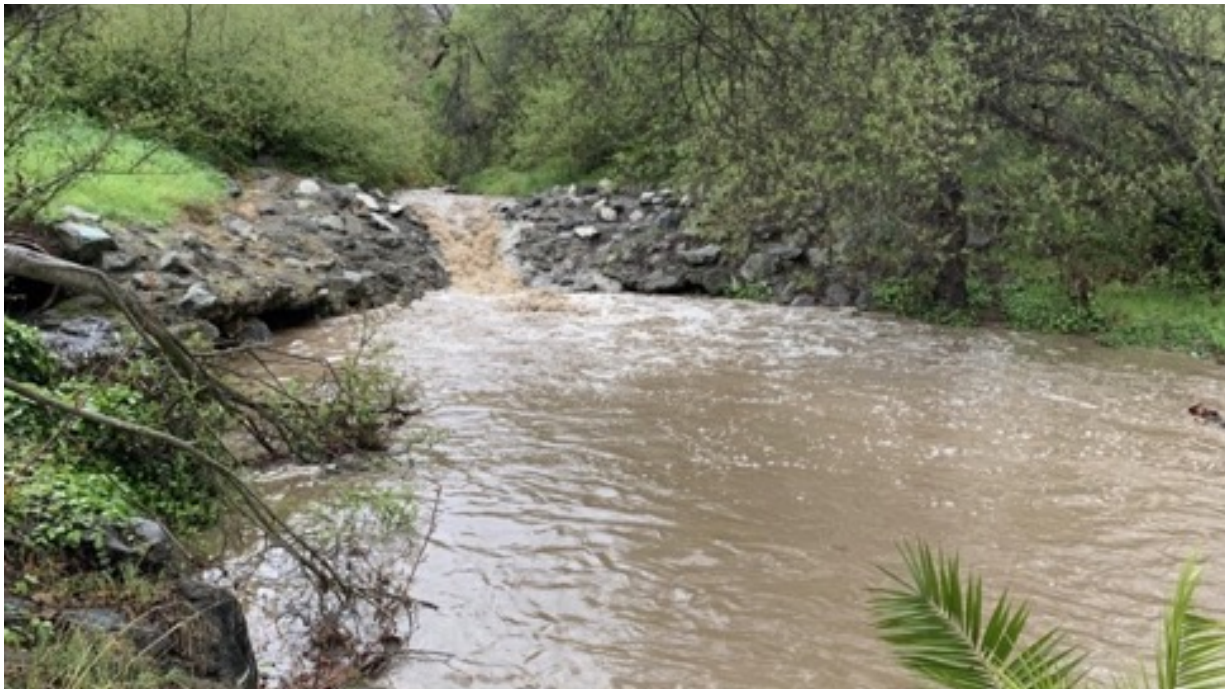
Figure 15. High flow at Little River Drive (LRD) on March 16, 2020, following substantial rain.

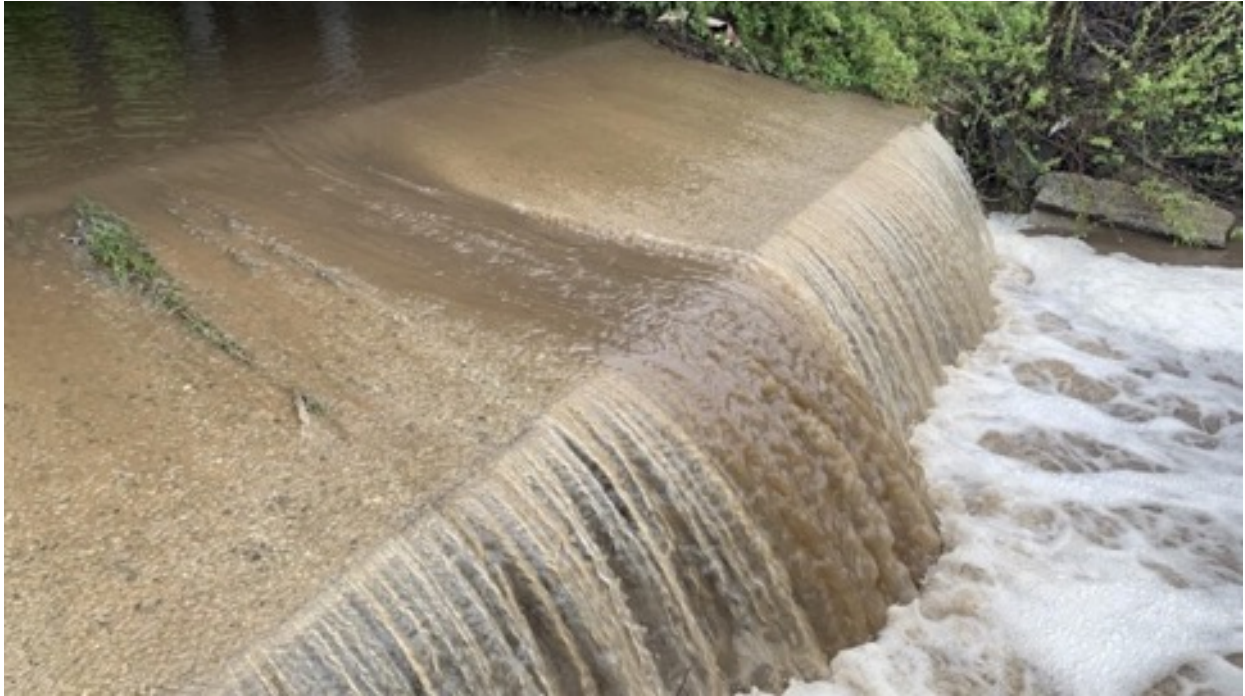
Figure 16. High flow at Hebert Road (HEB) on March 16, 2020, following substantial rain.

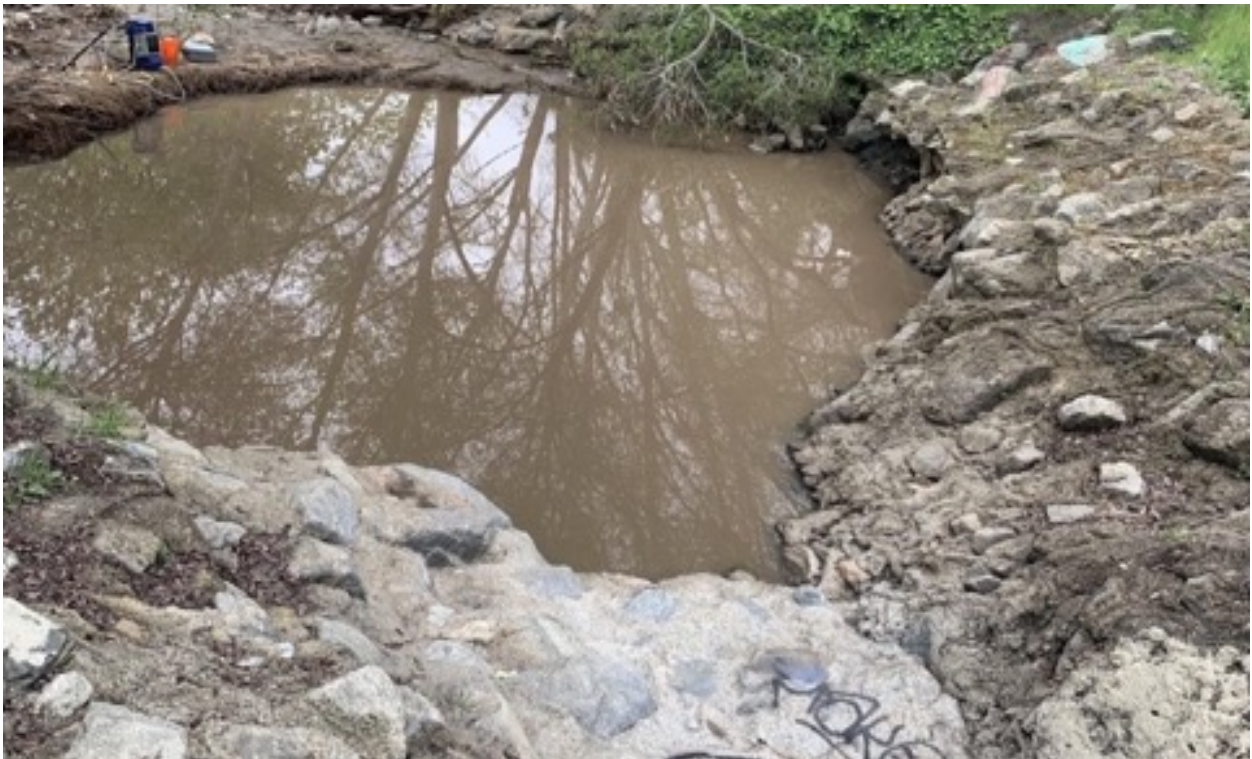
Figure 17. The pool at Little River Drive (LRD) on March 24, 2020. High flows during the preceding week washed a large amount of woody debris into the pool, which blocked nearly all outflow at the pool's downstream end.

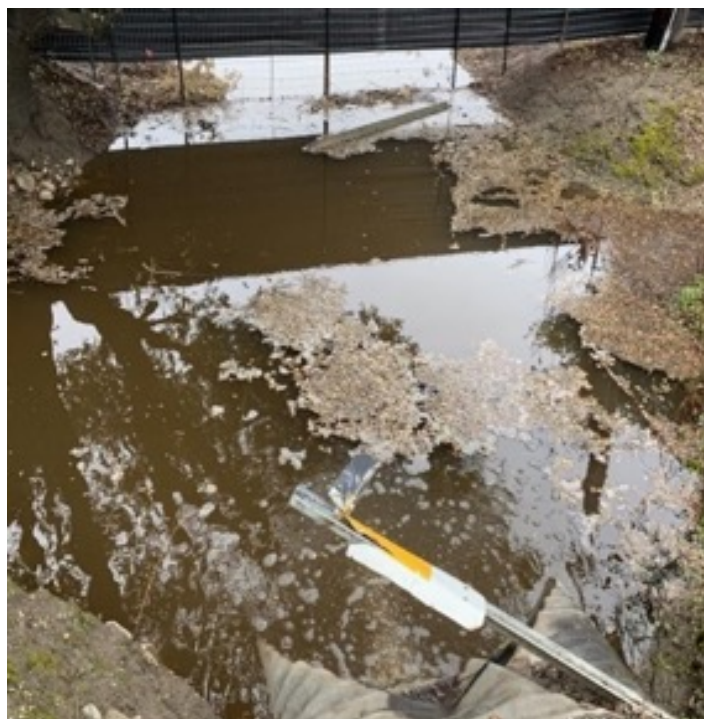
Figure 18. Natividad Creek (NAT) during the high flow period on March 16, 2020. Outflow was minimal, and the presence of a fence suggests passage by adult steelhead may be impossible.

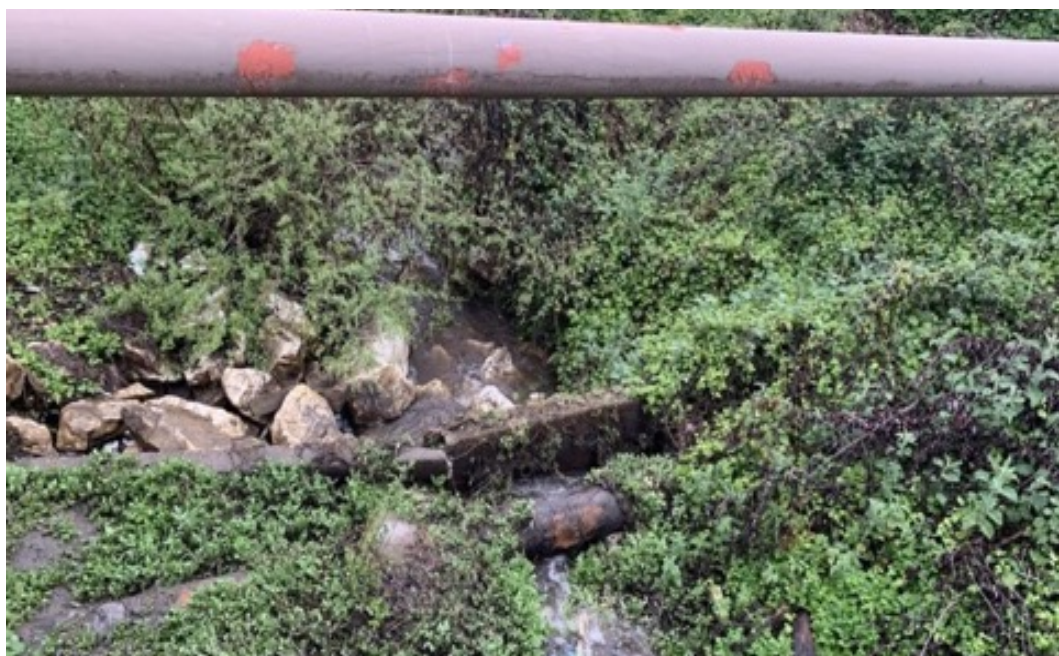
The barrier present at the highest site in the watershed that was surveyed in the 2020 monitoring season (SRC; Figure 1) did not appear passable even after the large flow events in March and April (Figure 19). Although water quality at this site was consistently suitable for *O. mykiss*, it appears unlikely that any anadromous individuals would have been able to reach it. Construction activity was noted under the Old Stage Road bridge on March 16 (Figure 20), but without apparent consequence for fish passage.

Figure 19. Old Stage Road crossing (SRC) on March 16, 2020, after a large precipitation event. The barrier consisting of a retaining wall and an old pipeline did not appear passable at any time during the 2020 monitoring season.

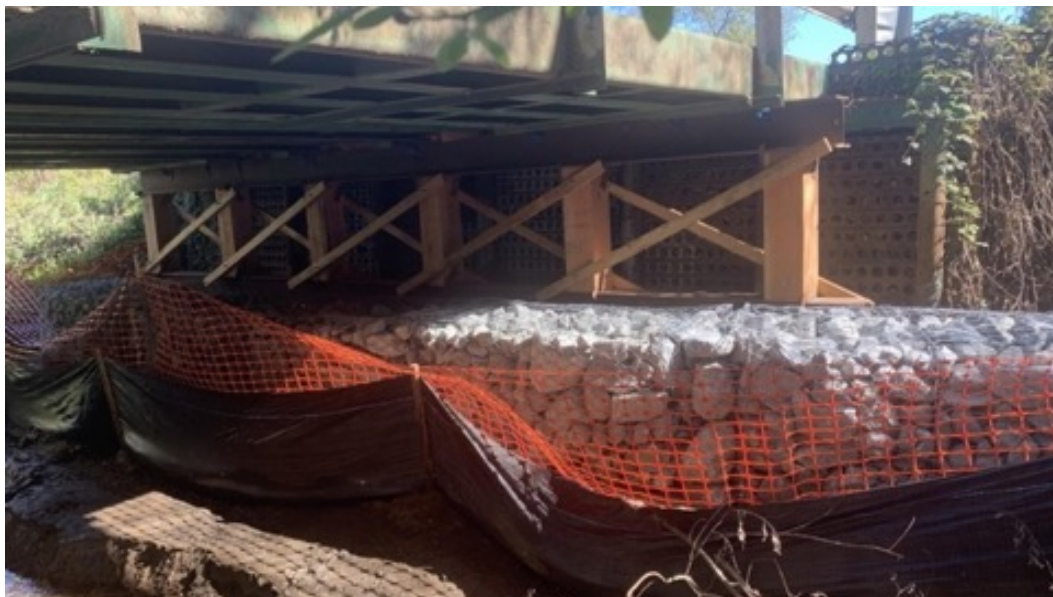
Figure 20. Bridge construction at Old Stage Road crossing (SRC). Photo taken March 31, 2020.

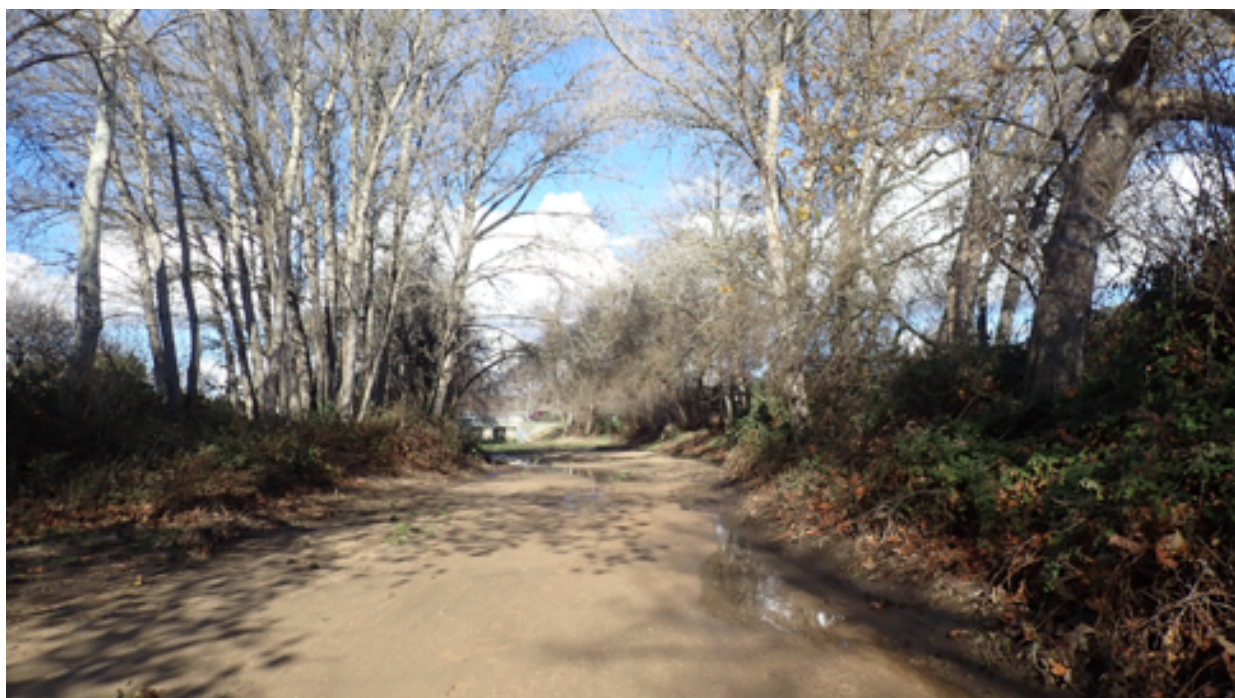
Figure 23. BOR on January 29, 2021, after 7.7 cm of rain fell in Salinas over the preceding three days. Although some small puddles suggest flow may have been recently present, no surface flow was observed between LRD and the Boronda Road crossing.

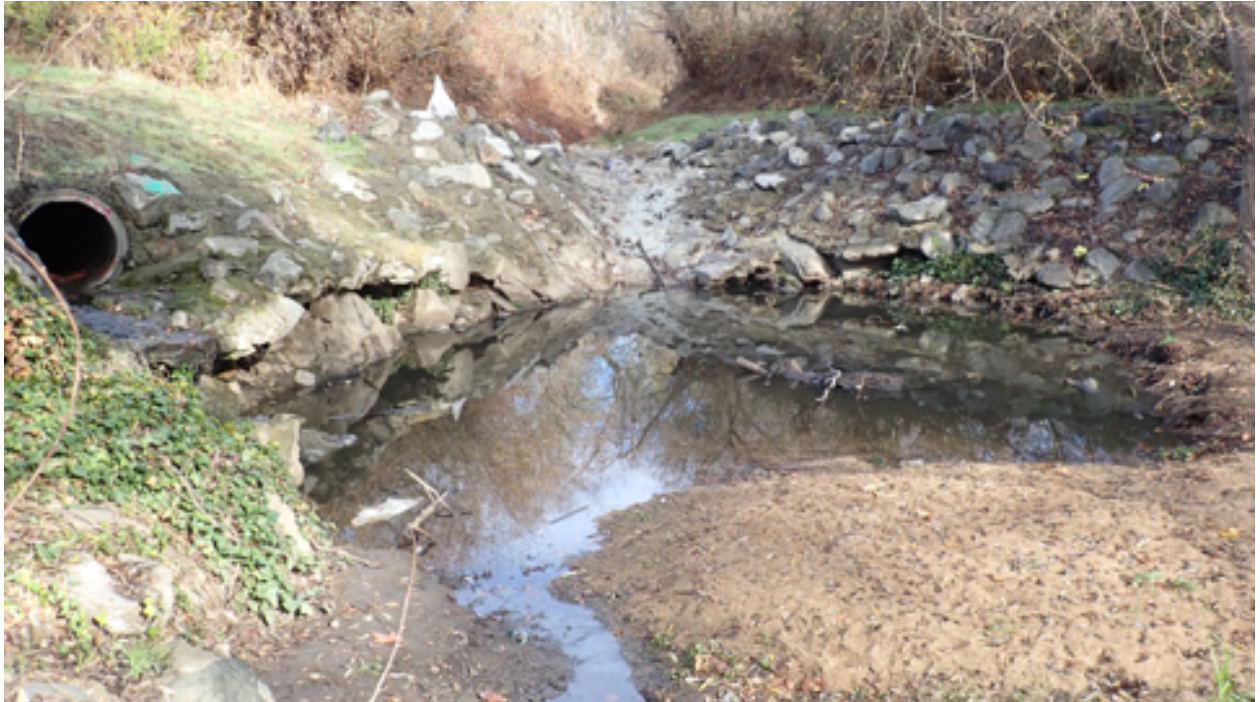
Figure 24. The barrier at LRD on January 29, 2021, after 7.7 cm of rain fell in Salinas over the preceding three days. Despite the heavy precipitation, there was no flow observed above the barrier at LRD.

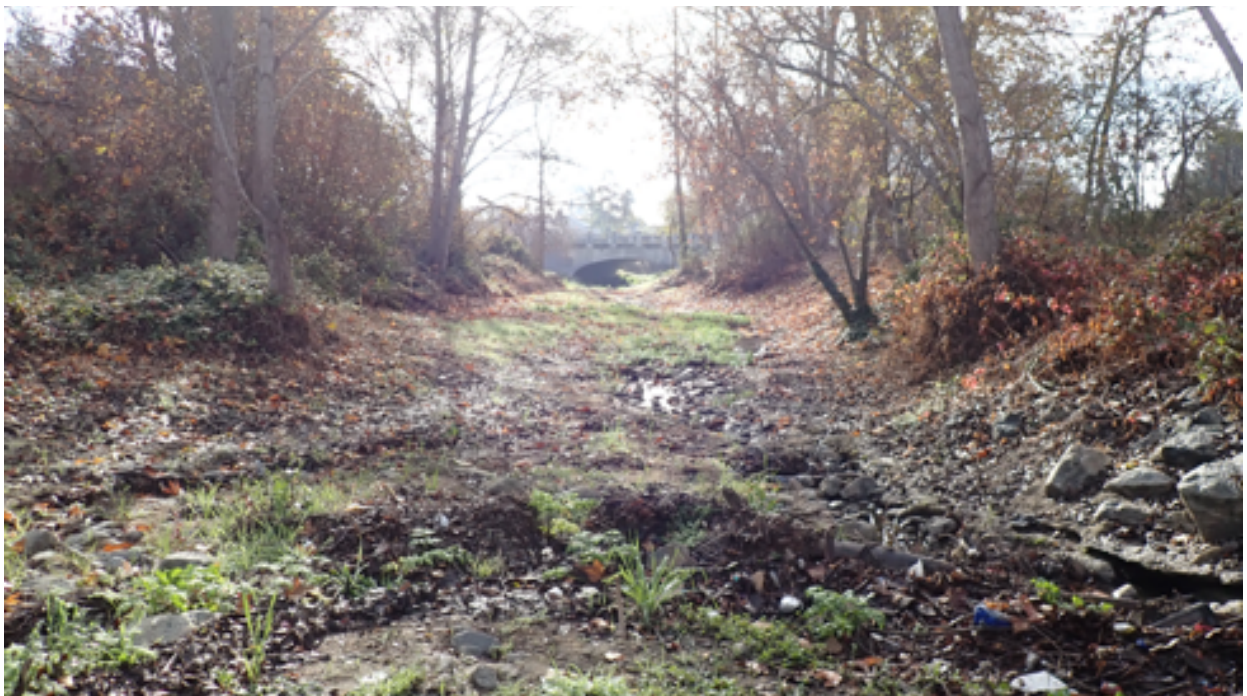
Figure 25 Facing downstream from the barrier at LRD on January 29, 2021, after 7.7 cm of rain fell in Salinas over the preceding three days. Although water remained in the pool at LRD, there was no downstream flow.

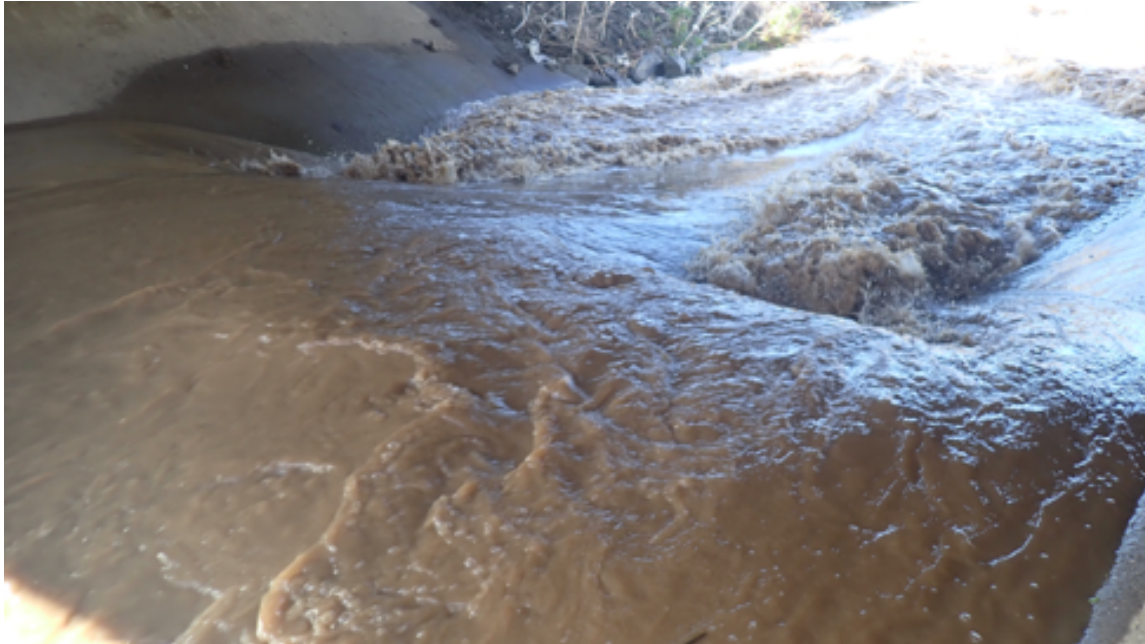
Figure 26. SJR on January 29, 2021, after 7.7 cm of rain fell in Salinas over the preceding three days. The river stage was 3.7 feet as measured by the gauge at the San Jon Road crossing, which was 1.64 feet higher than the next highest stage observed across the entirety of 2020-2021 monitoring.

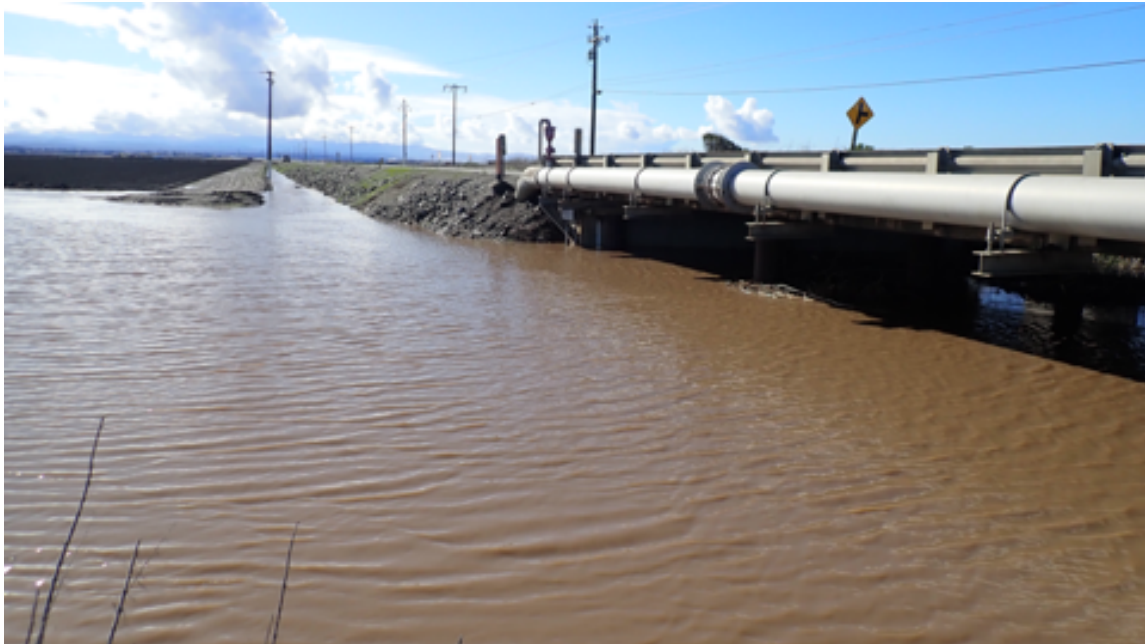
Figure 27. TEM on January 29, 2021, after 7.7 cm of rain fell in Salinas over the preceding three days. The river stage was 18 feet as measured by the gauge at the Molera Road crossing. No eDNA sample was collected from the site on this date due to excessive sediment that repeatedly clogged the collection filters.

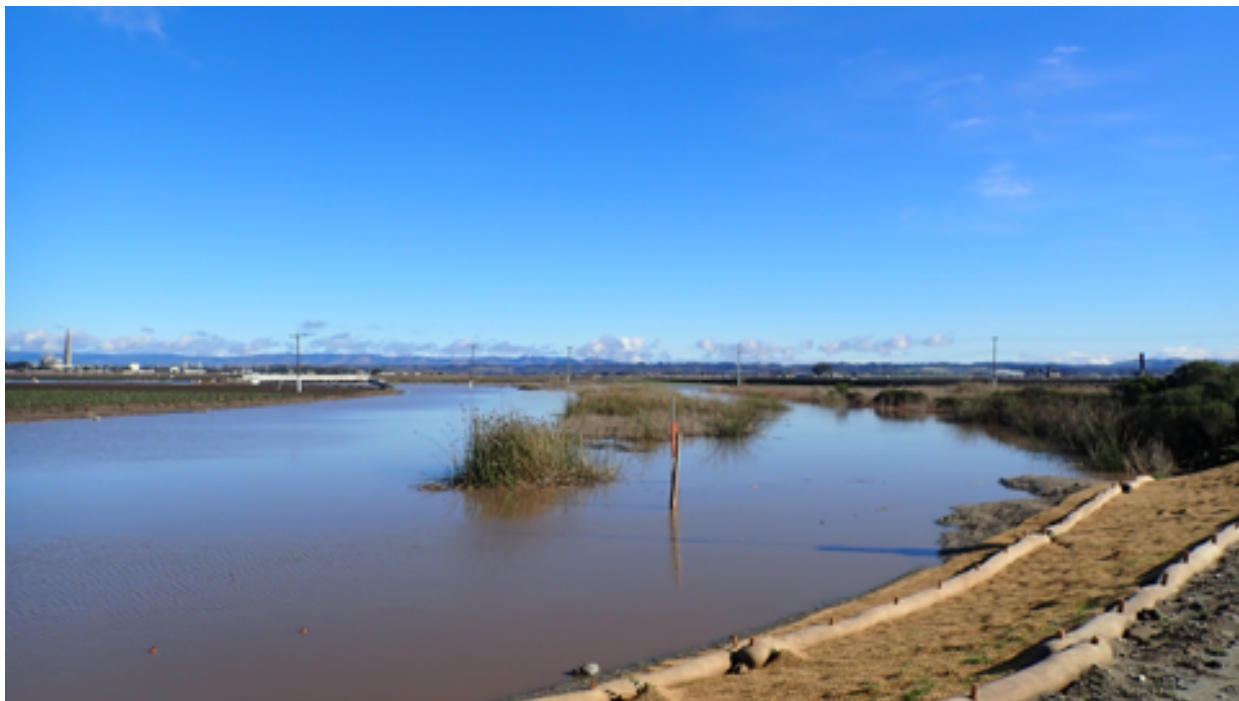
Figure 28. OSR on January 29, 2021, after 7.7 cm of rain fell in Salinas over the preceding three days. The river stage was 3.5 feet as measured by the gauge at Monterey Dunes Way, which was 0.5 feet higher than the next highest stage observed across the entirety of 2020-2021 monitoring.

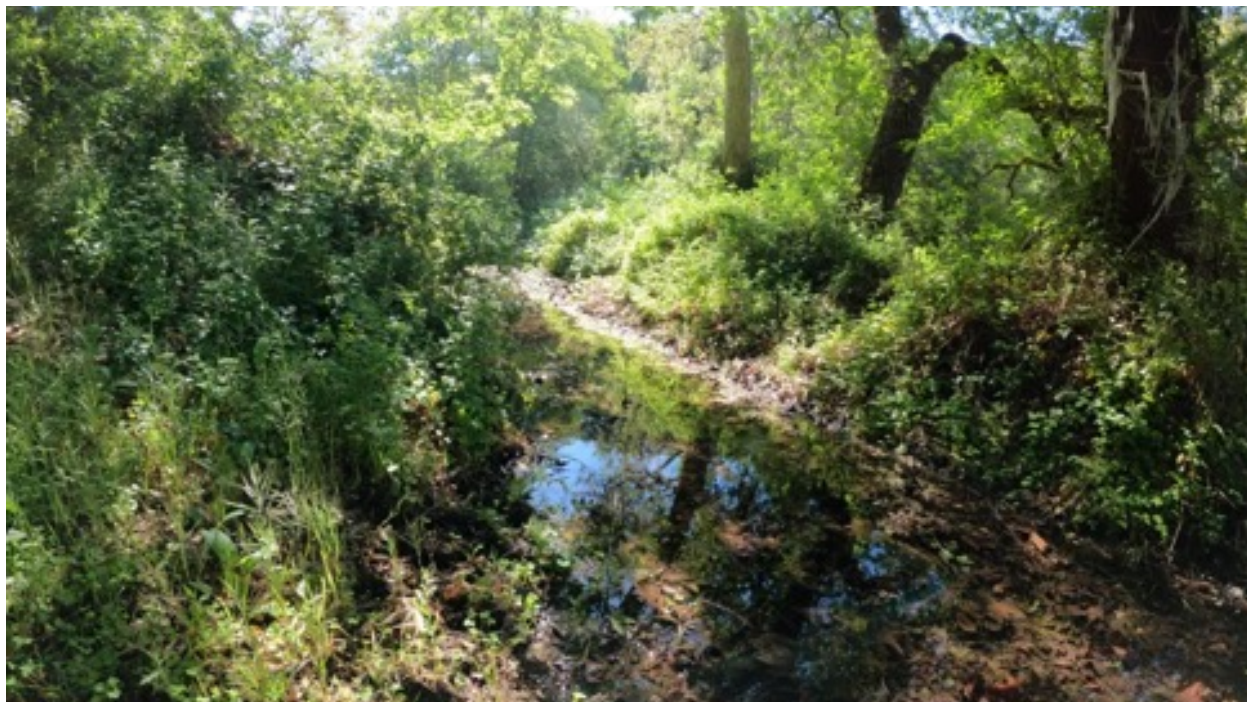
Figure 31. BDR1 facing upstream. This was the furthest upstream observation of wetted channel in the system.

The furthest upstream site (BDR1; Table 10, Figure 30) was near the emergence of Gabilan Creek from a steep, boulder filled canyon in the Gabilan Mountains and enters the uppermost portion of the valley floor. Although FISHBIO personnel were unable to access the canyon itself, the landowner indicated that the streambed is very steep and flows through numerous boulders that are greater than 10 feet in diameter. BDR1 was a short run containing a minimal amount of water, and the streambed was dry immediately upstream and downstream, making it functionally a long, shallow puddle at the observed water level (Figure 31, Figure 32). It appeared the streambed was completely dry upstream from BDR1 to at least the entry to the canyon. Notably, this was the only wetted reach in the upper watershed where no fish were observed. The landowner indicated that this upper reach is typically dry by June, and that there had been no flow in this portion of the creek during the spring of 2021. The streambed at this site, and for essentially the entirety of its length on the Bardin Ranch property, consisted primarily of cobble and gravel substrates, which appeared to be suitable for *O. mykiss* spawning.

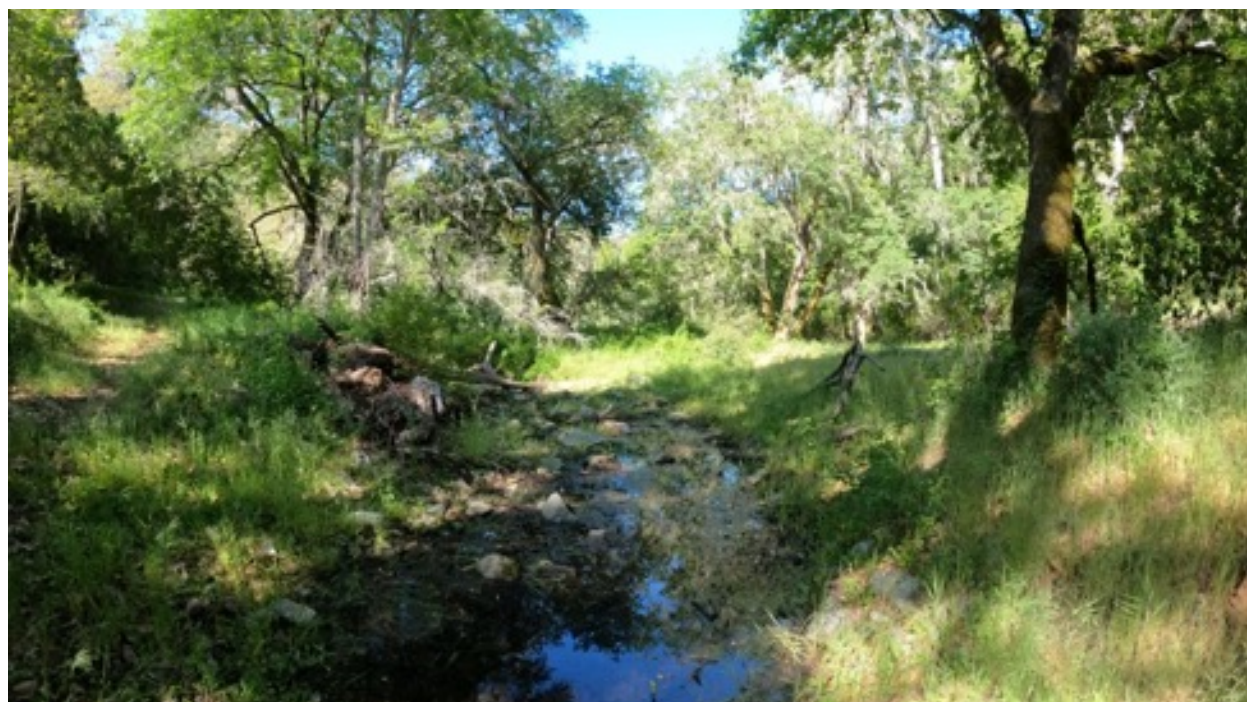
Figure 32. BDR1 facing downstream. The streambed was dry for approximately 5.73 km below this point.
