Gabilan Creek Watershed Monitoring Report

January 2020 – May 2021

Submitted To:
Monterey County Water Resources Agency

Prepared By:
Jack Eschenroeder
Dana Lee

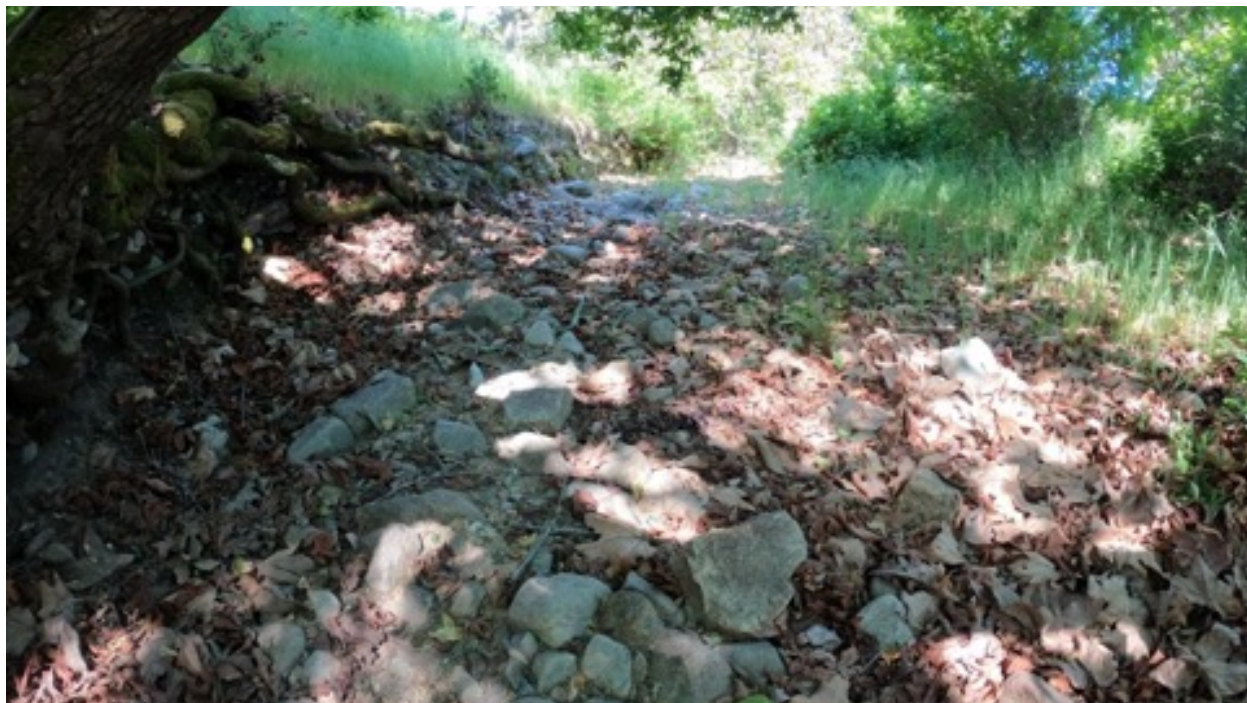
Figure 33. A dry portion of the streambed between BDR1 and BDR2, facing downstream. The predominant substrate was cobble, and the accumulation of leaf litter suggests no flow had occurred recently.

Downstream of BDR1, the creek remained dry for approximately 5.7 km, and the presence of large amounts of leaves and other detritus in the streambed suggested that little or no flow had occurred recently (Figures 33, 34). This long, dry section of riverbed was characterized by gentle gradient, gravel and cobble substrate, and nearly complete riparian cover, indicating high potential as quality spawning and rearing habitat when wetted. The next wetted channel reach was not observed until reaching BDR2 (Table 10, Figures 35, 36), which was a short run section that flowed downstream into BDP1 (Table 10, Figure 37), a pool on an outside bend. Gravel was the predominant substrate at both sites, and multiple *O. mykiss* were observed (estimated average fork length 100-150 mm). The landowner indicated that small *O. mykiss* can reliably be caught with hook and line at BDP1.

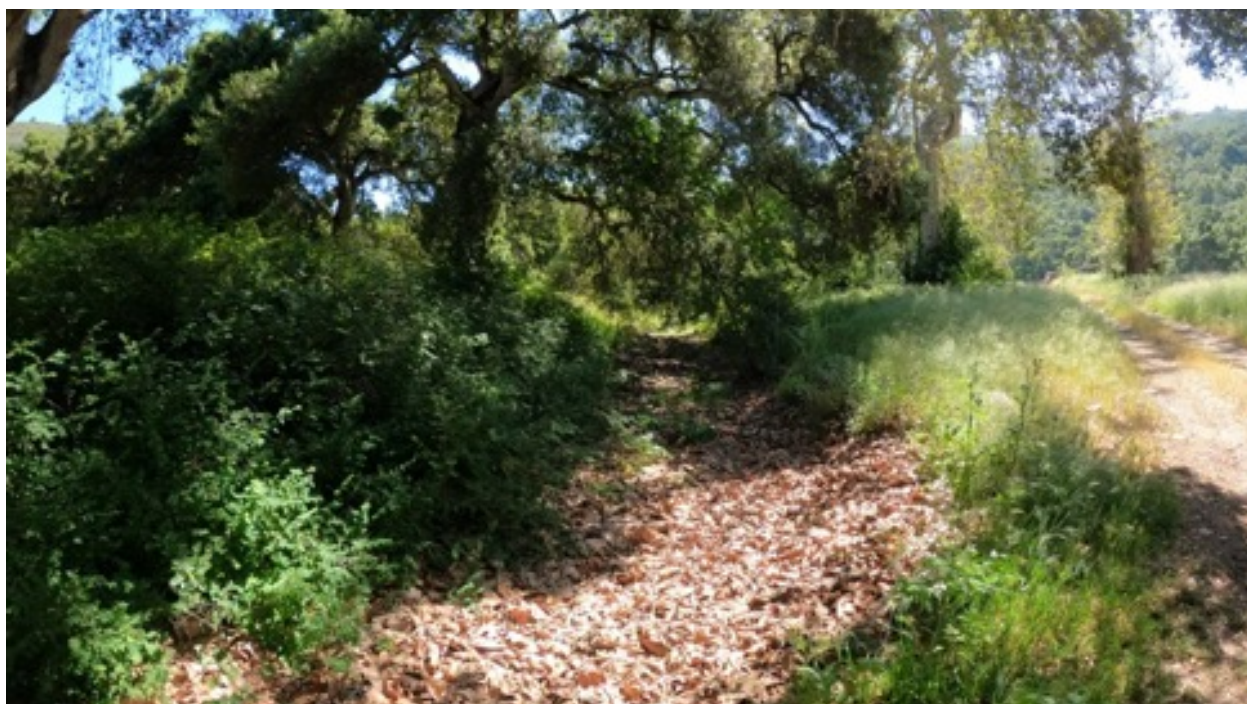
Figure 34. A dry portion of the streambed between BDR1 and BDR2, facing upstream. The predominant substrate was cobble, and the accumulation of leaf litter suggests no flow had occurred recently.

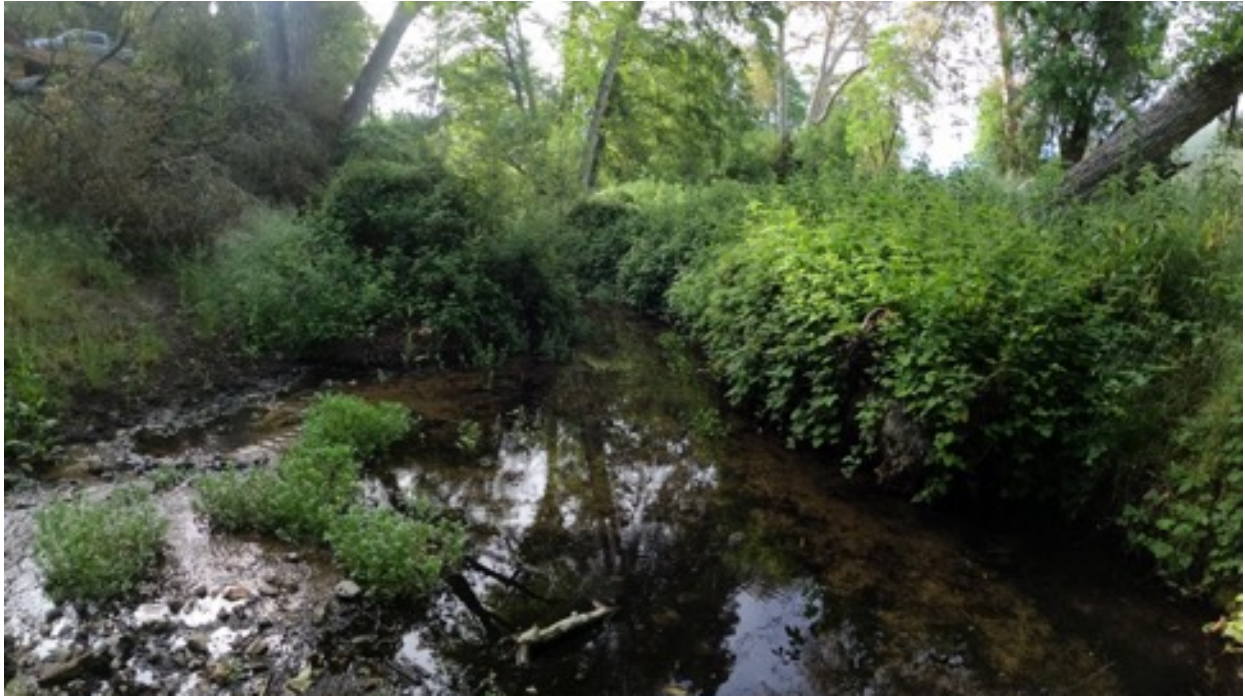
Figure 35. BDR2 facing upstream. Multiple *O. mykiss* were observed in this reach.

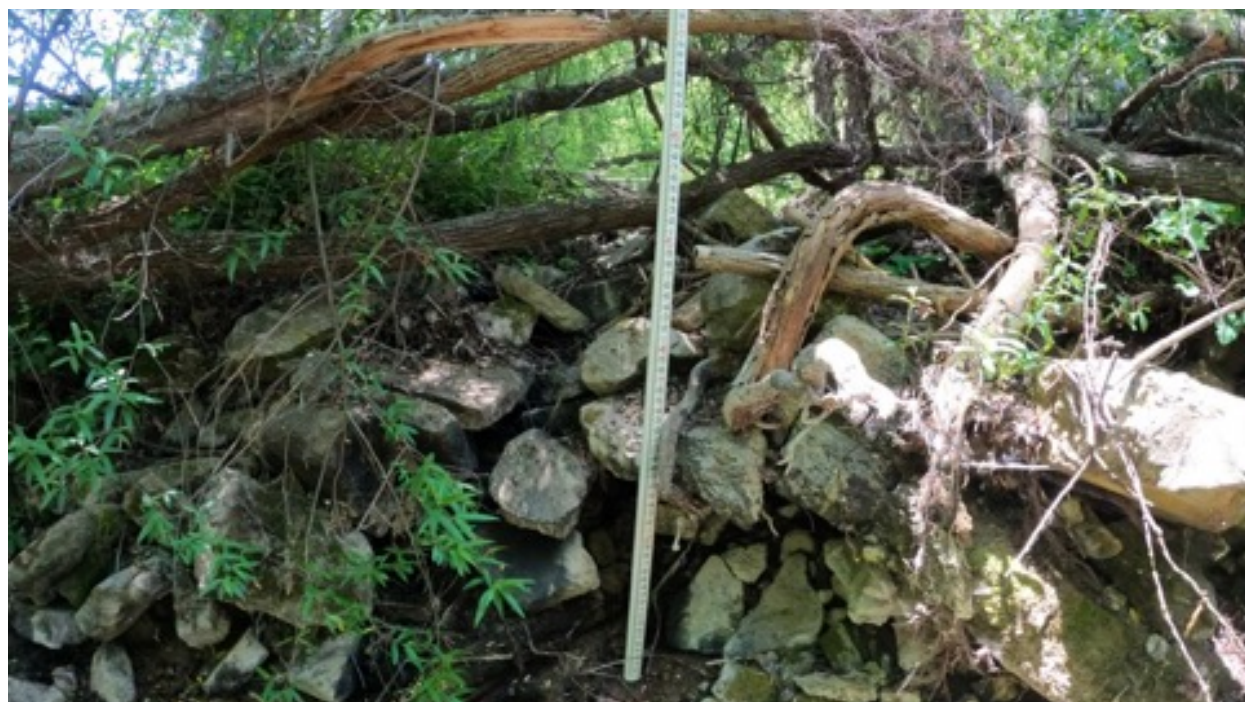
Figure 38. VRB facing upstream. This barrier of concrete, rebar, and woody debris stood approximately 1.68 m tall (5.5. feet). The very shallow puddle visible at the bottom was the furthest upstream observation of water on the Vierra Ranch property.

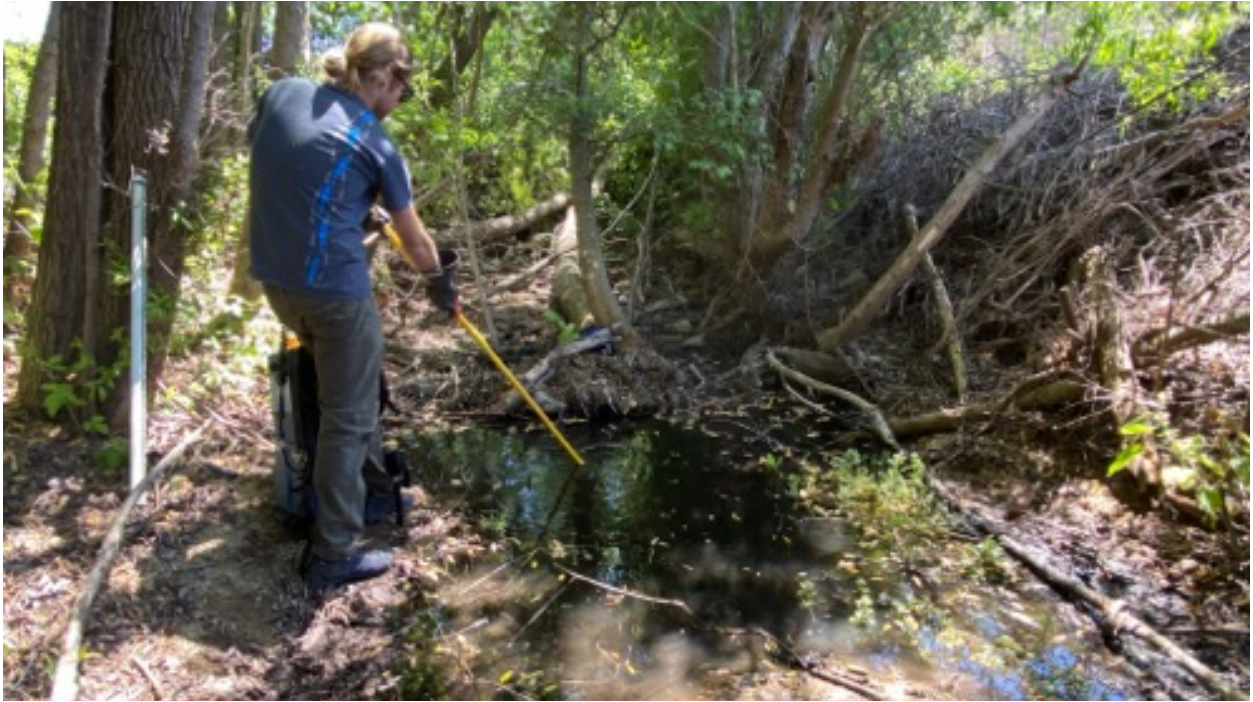
Figure 39. VRP1 facing upstream, approximately 15 m downstream of VRB. Despite very poor water quality and restricted habitat, eight *O. mykiss* were captured in this pool.

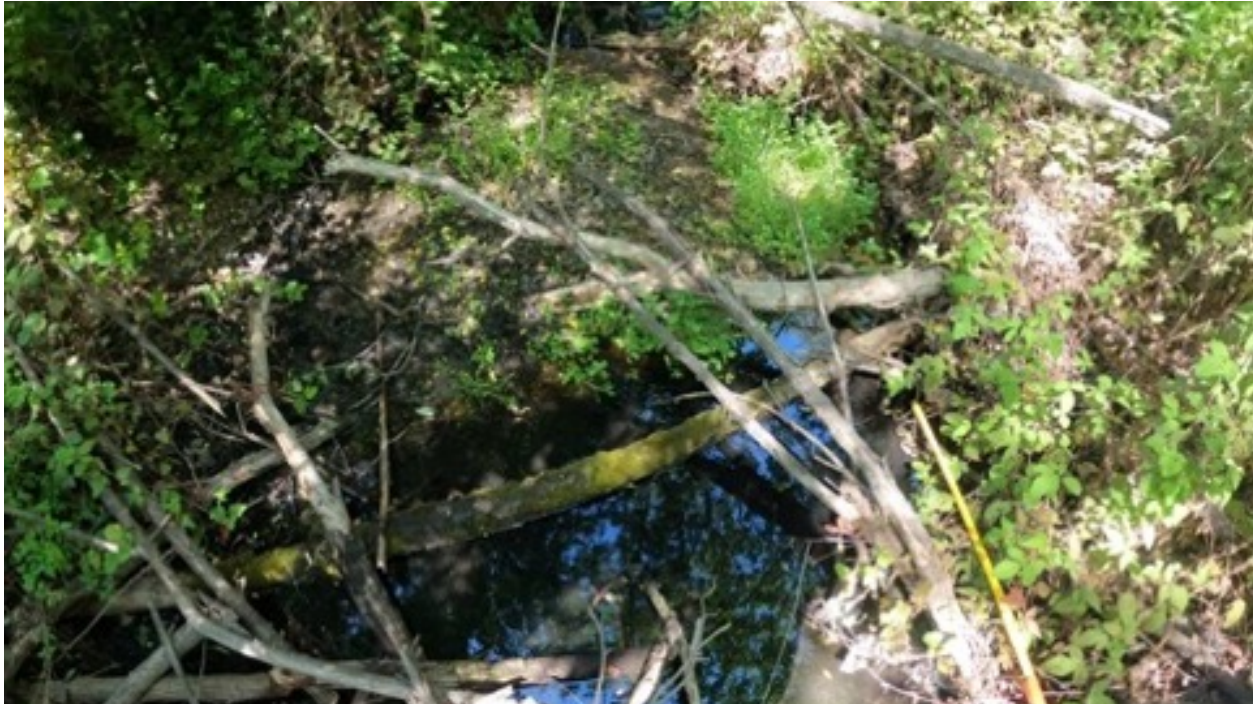
Figure 41. VRP3 facing downstream. There appeared to be continuous flow downstream of this location, but dense vegetation prevented FISHBIO personnel from travelling further along the streambed.

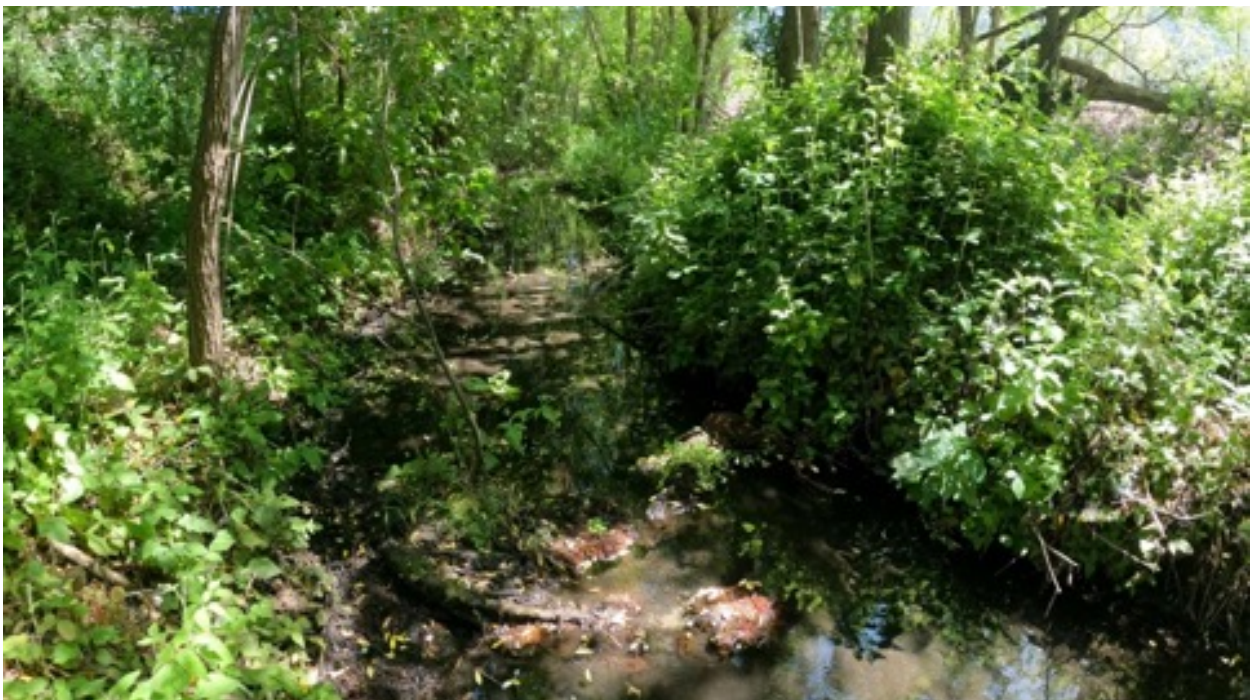
Figure 42. VRR1 facing upstream. This run was approximately 20 m long and ended in a small pool.

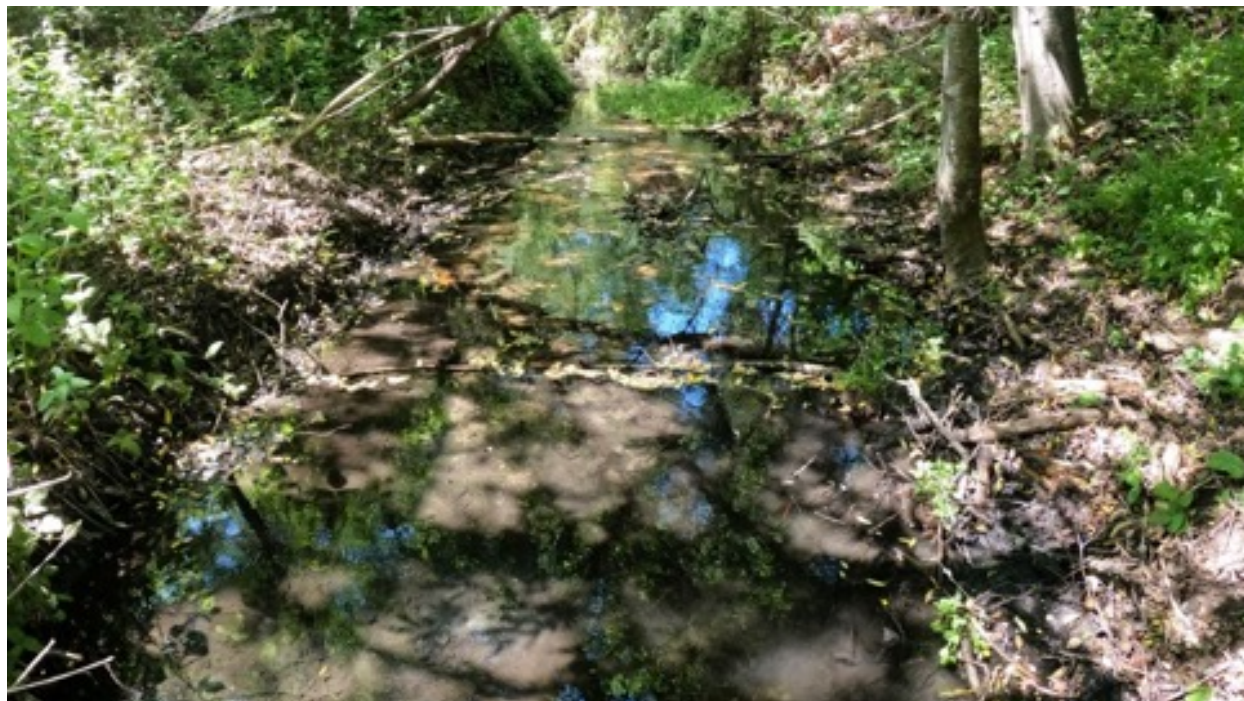
Figure 43. VRR1 facing downstream. The pool that was considered the end of VRR1 sample site is in the center of this photo.

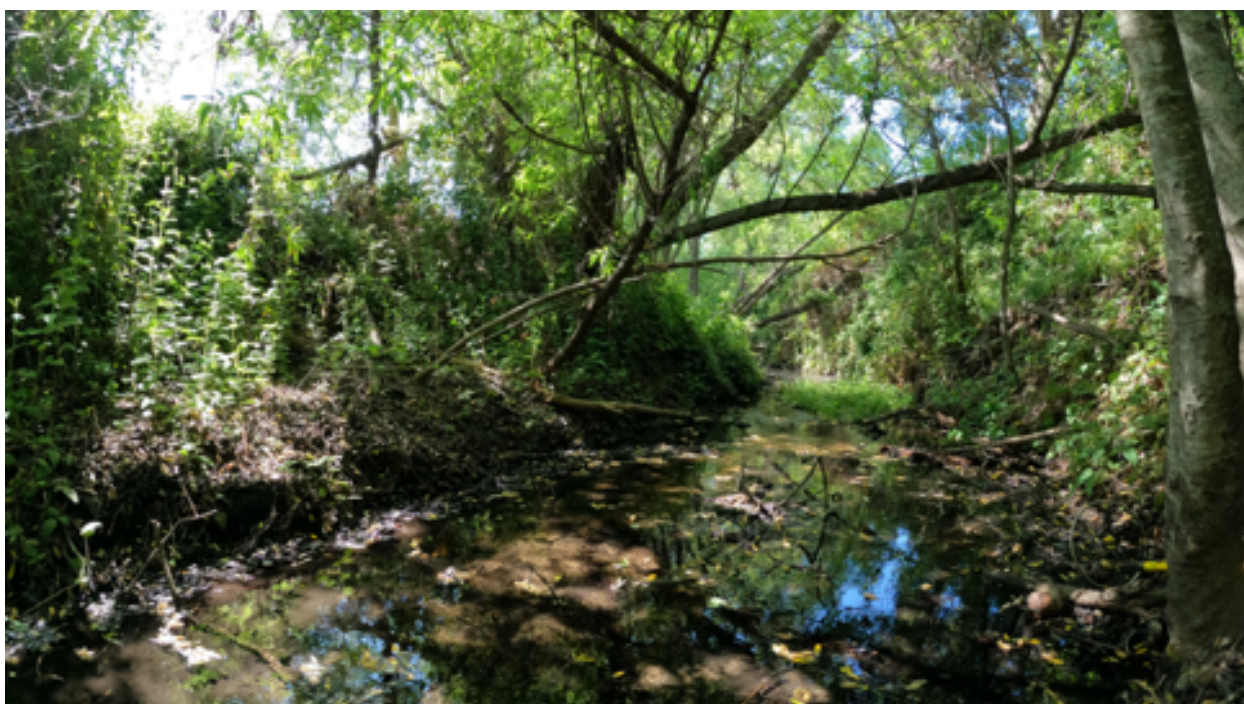
Figure 44. VRR1 facing downstream. Downstream flow appeared to be continuous from here through VRR2.

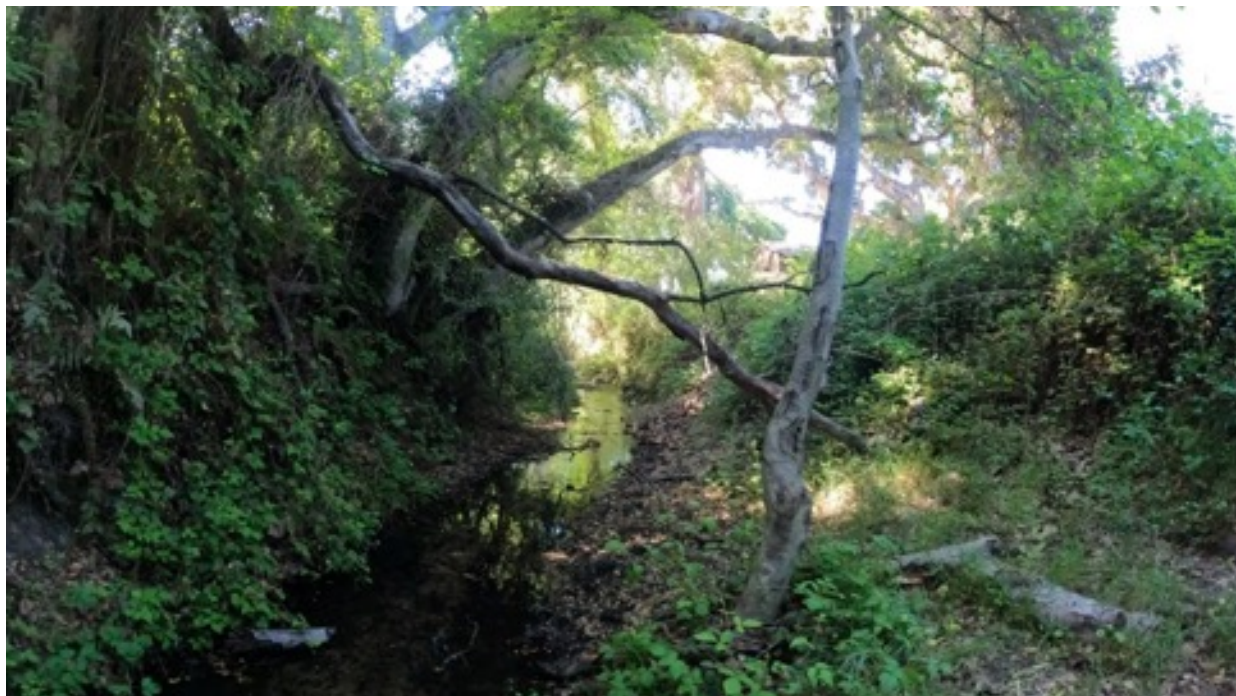
Figure 45. VRR2 facing downstream. Flow appeared to be continuous from here nearly to the Old Stage Road crossing (SRC) at the property border.

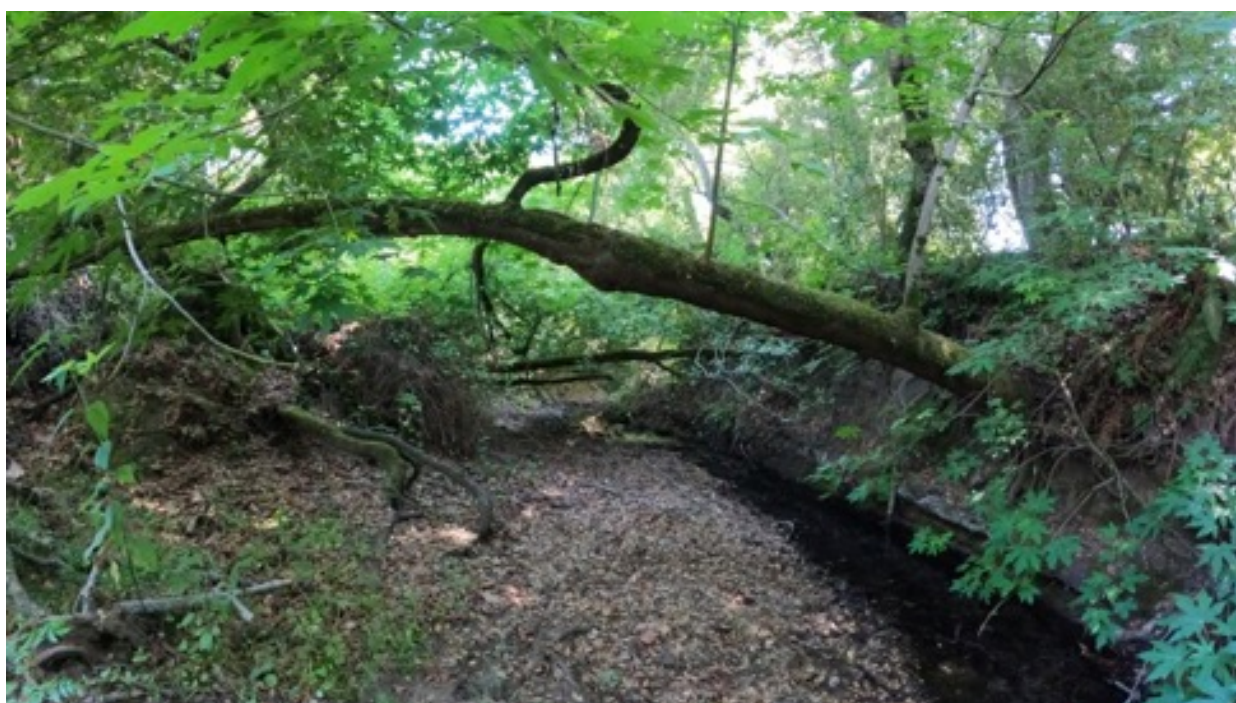
Figure 46. VRR2 facing upstream. The bank area on the inside of this bend showed signs of heavy use by cattle. Two *O. mykiss* were observed in this reach, but only one was captured.

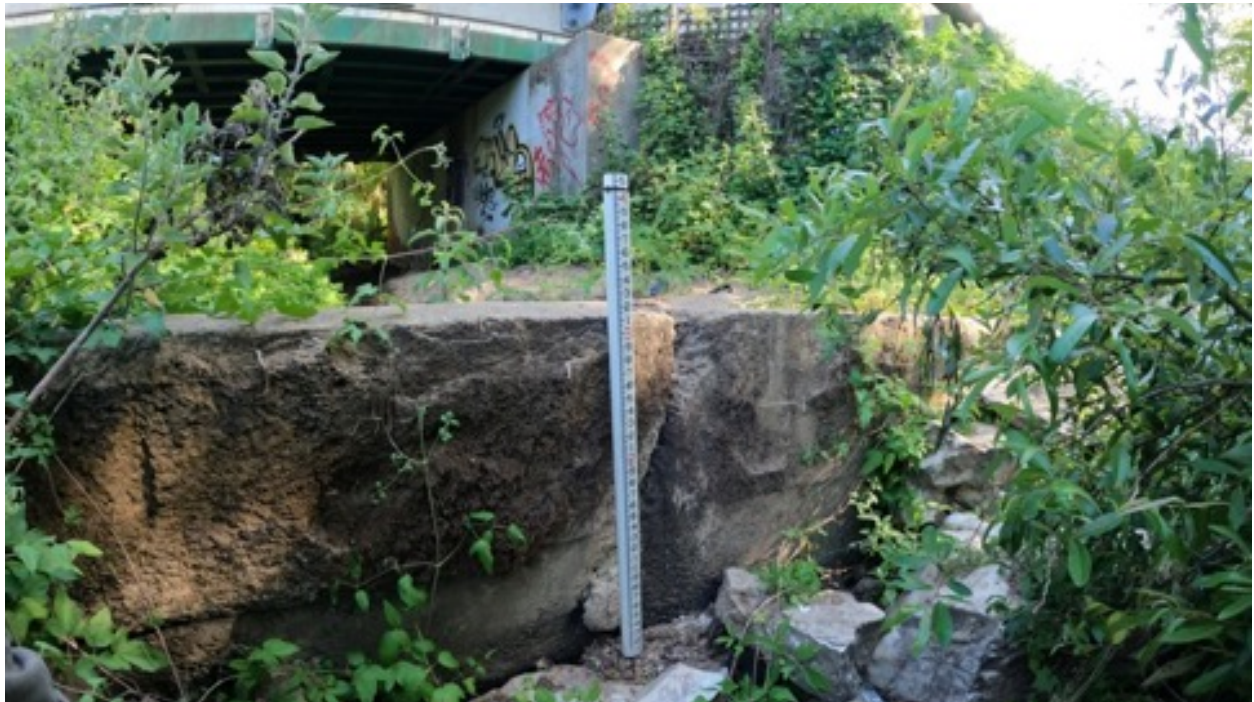
Figure 47. The barrier downstream of the Old Stage Road crossing (SRC). The height of the retaining wall was approximately 0.98 m (3.2 feet). Flows sufficient to allow for passage over this structure were not observed during 2020 or 2021 sampling (see Figure 19 for an overhead view during a period of flow).
